RCA-07/0049/70

**Basic Imagery Interpretation Report**

**SIRUME ARMY BARRACKS**

**GROUND FORCE FACILITIES  
NORTH KOREA  
DECEMBER 1969**

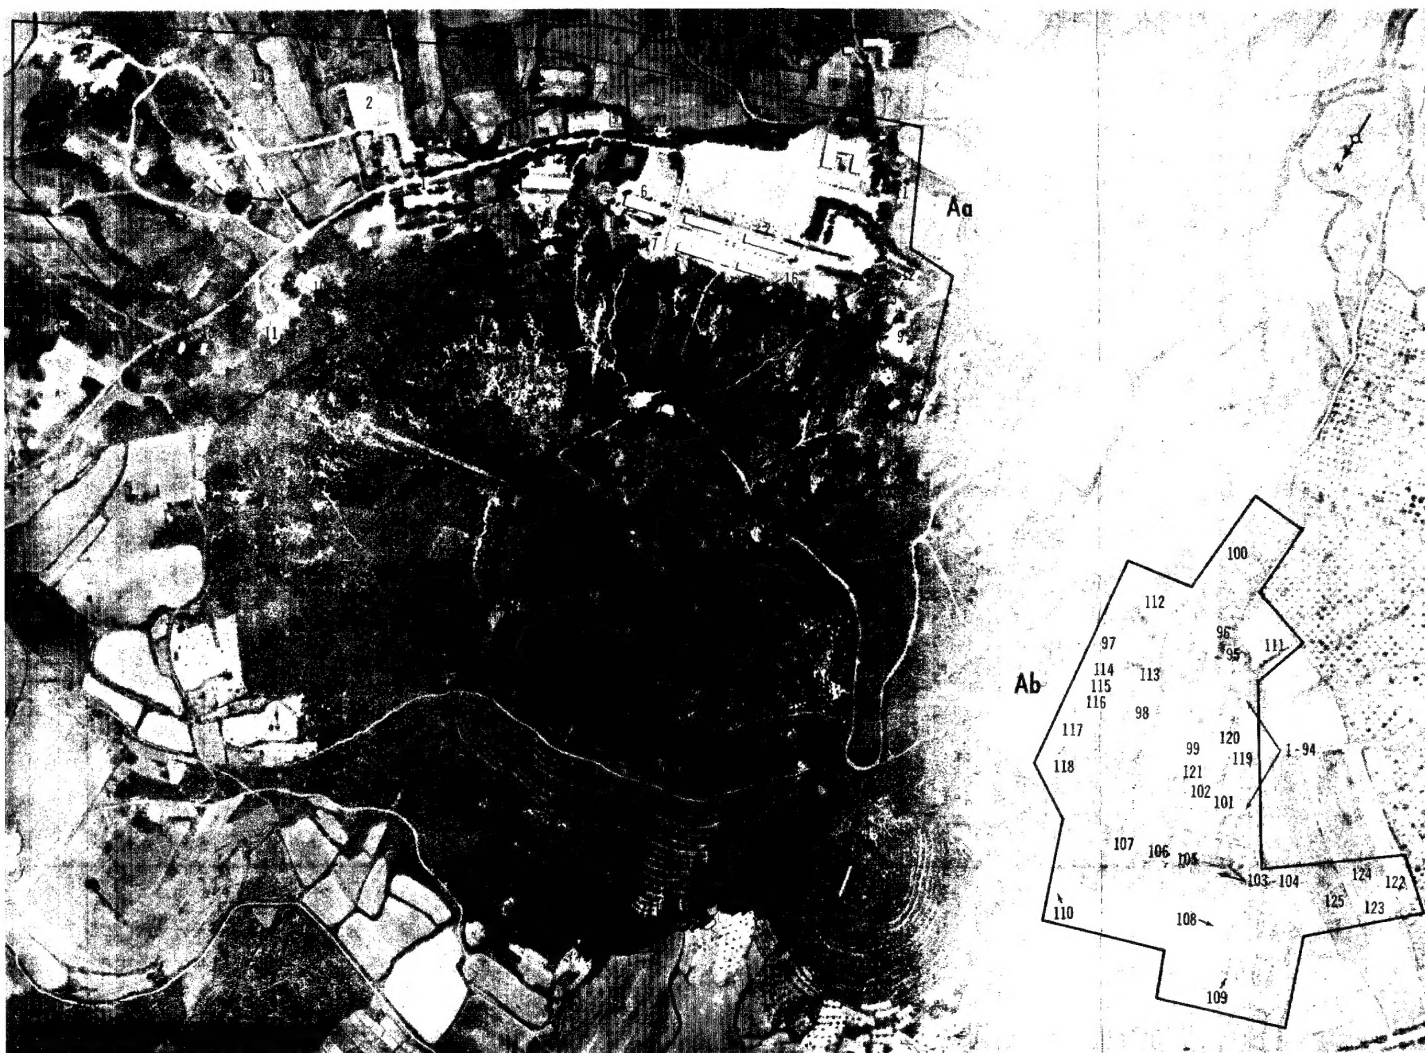
FIGURE 1. SIRUME ARMY BARRACKS, NORTH KOREA

BUILDING NO
<b>BILLETING AREA</b>	
Aa 4 barracks	1
	2
	3
	4
2 admin bldgs	5
	6
1 messhall	7 wing 1
	wing 2
	center section
1 prob ammunition storage	8
1 storage bldg	9
11 support bldgs	10
	11
	12
	13
	14
	15
	16
	17
	18
	19
	20
1 obstacle course	21
Ab 96 quarters	1-94
	95-96
2 admin bldgs	97 overall
	wing
	98
1 auditorium	99
23 support bldgs	100-110
	111
	112
	113
	114
	115
	116
	117
	118
	119
	120
	121
	122 overall
	wing
3 animal pens	123-125
<b>GENERAL STORAGE AREA</b>	
C 1 barracks	1
1 vehicle shed	2
9 storage bldgs	3-7
	8
	9
	10
	11
5 support bldgs	12
	13
	14
	15
	16
